Manhole Inspection Summary

Manhole # S17001017MH

Insp Date: **11/30/07 10:19 AM**

Location Address: **TAMARIND RD**

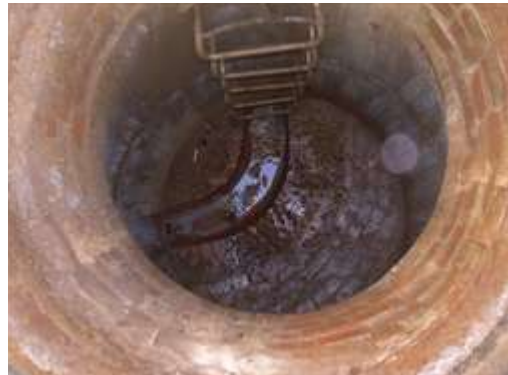
Top View

Evidence of surcharge - Bench debris.
Channel debris.

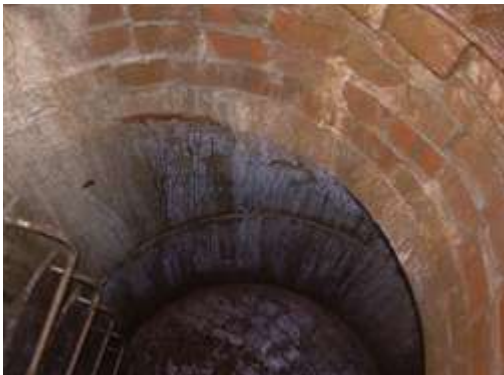
Defect

Frame leaks. Adjustment deterioration
and infiltration. Corbel and Barrel
infiltration.

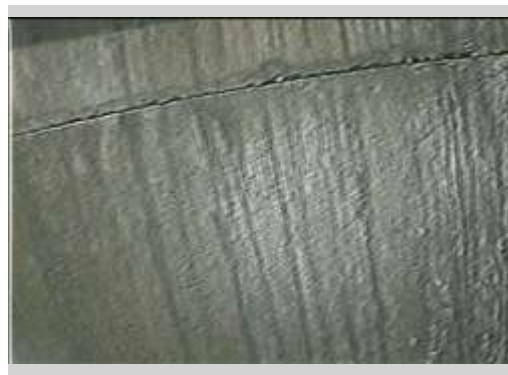
Defect

Barrel infiltration.

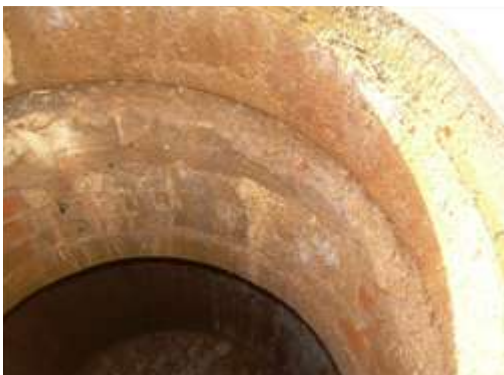
Defect

Frame leaks. Frame offset. Adjustment
deterioration and infiltration.

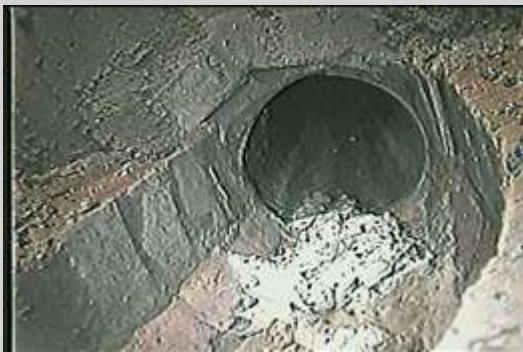
8 in. Circular Gravity Sewer Pipe Out @ 12 O'Clock

Deposits: ☐ None ☐ Mud ☐ Sludge ☒ Debris ☒ Grease

Silt Depth: **0.5** (in.) Deposits Extent: **Light**

Infiltration: **Evidence** Pipe Seal Cond: **Unknown**
